CASE REPORT

The unexpected complications of the left bundle branch area pacing (LBBAP) maneuver: a case report

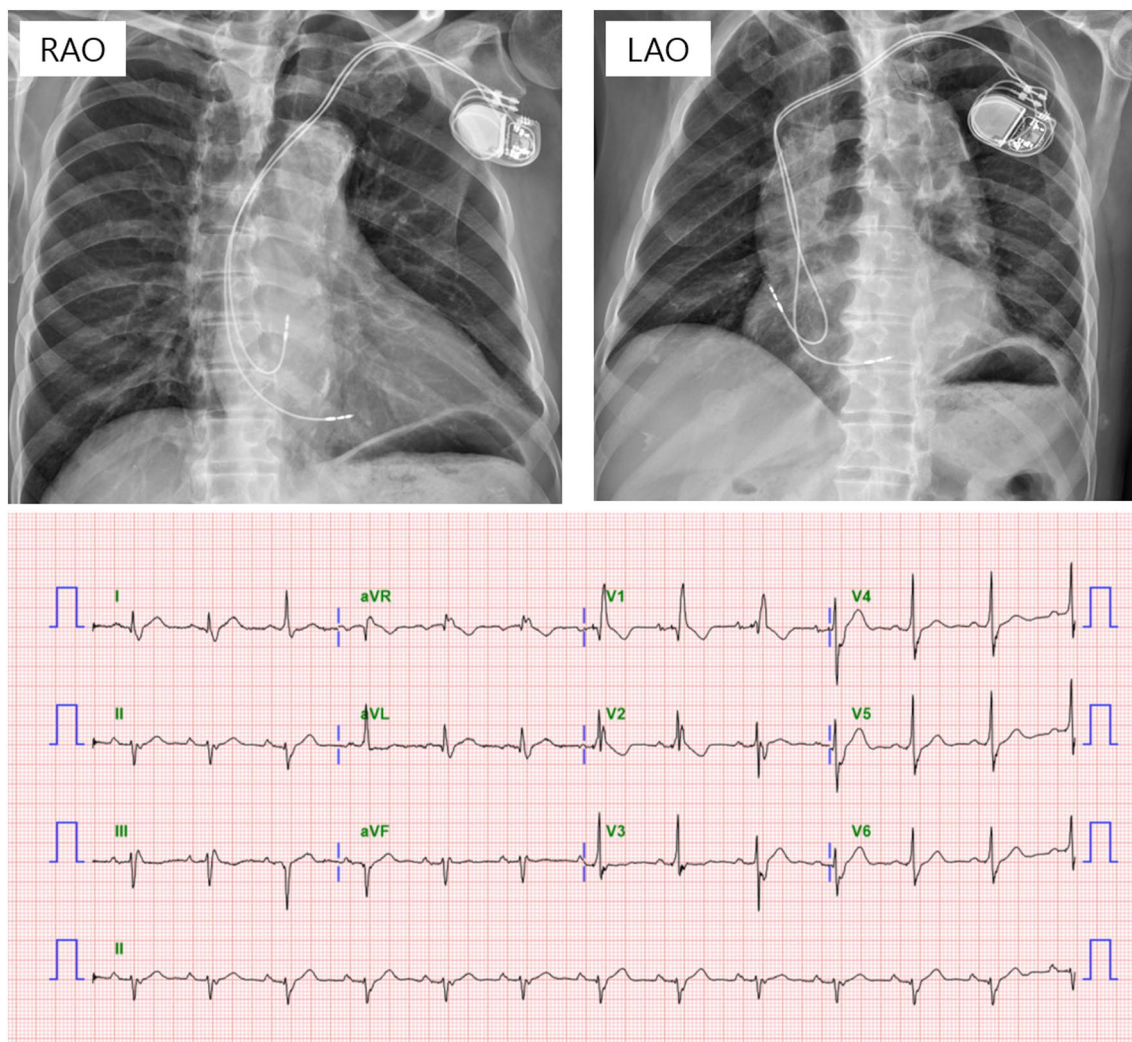
The patient, a 76-year-old man, underwent pacemaker insertion with a CAVB in June.2022. DDD type of pacemaker with LBBAP (Biotronik, Solia S60) was inserted. The baseline rhythm of the patient was RBBB, and pacing rhythm was also RBBB pattern. From the pattern, it can be inferred that the lead was located near the LBB area. At that time, the value of the pacemaker was within the normal range (V lead: sensing threshold–10.9, pacing threshold–1.7 voltage, impedance–507 Ω). (Fig. 1) He was discharged without any incident. However, one month later, the capture threshold of V lead was increased to 7.5 voltage and the unstable status of ventricular capture was identified. The capture threshold did not be normalized even with follow-up, so the revision of

Fig. 1 Initial chest X-ray and ECG after LBBAP procedure. The V lead was positioned at the septal area on the RAO and LAO view of chest X-ray. The RBBB pattern of the rhythm was maintained with V pacing

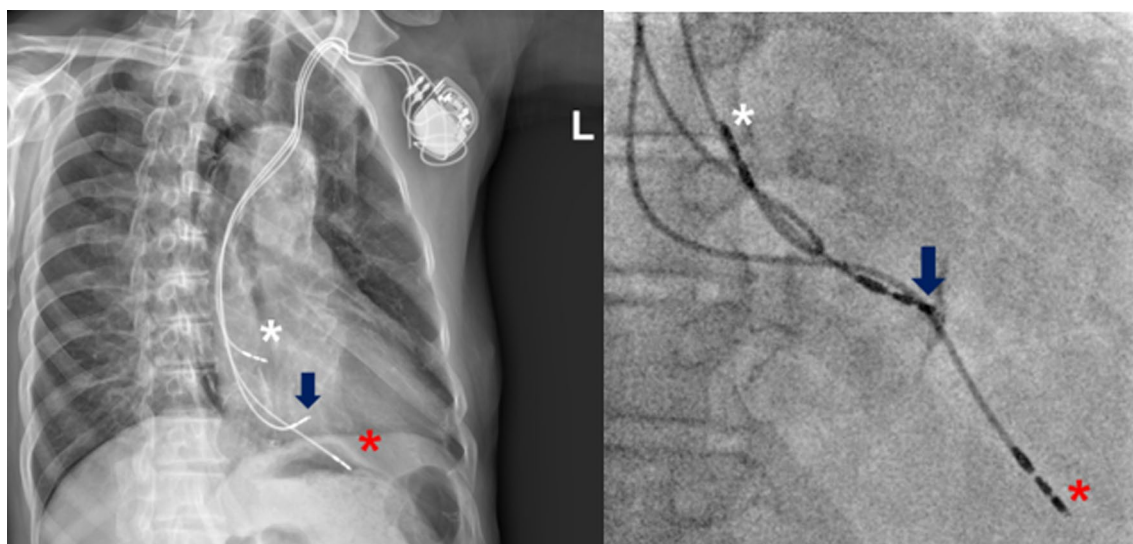
the V lead was conducted in January, 2023. In the process of the procedure, we tried to reposition the lead to the right ventricular septal area. However, we failed to unscrew and could not extract the V lead manually. An extraction device was not used because adhesion to the vessel was not suspected. Despite several attempts to remove the existing lead by transvenous lead extraction, the extraction failed. At that time, the tip of the lead was trapped in the ventricular myocardium tightly due to the malfunction of the screw. Therefore, we did not attempt to extract the lead with an extraction device aggressively because of the possibility of myocardial damage. The procedure was completed with the insertion of additional V lead at the apex of the right ventricle (RV) without extraction of V lead previously inserted (Fig. 2).

Fig. 2 Failure of V lead extraction. Chest X-ray (RAO view). Atrial lead (white asterisk) was inserted in the right atrial appendage (RAA). The V lead previously inserted for LBBAP was into the part of the septum (blue arrow). Additional V lead for conventional pacing was positioned at the apex

traction maneuver, the malfunction of the helix and the lead not being separated from the septum made TLE more challenging in some cases [3, 4]. In our case, the cause of the failed extraction of the V lead and the abrupt increase of the pacing threshold would be derived from the malfunction of the helix. However, for an accurate assessment of the case, it is necessary to remove the lead and visually evaluate it. Therefore, it would be needed to further maneuver rather than simple traction and conventional extraction devices.

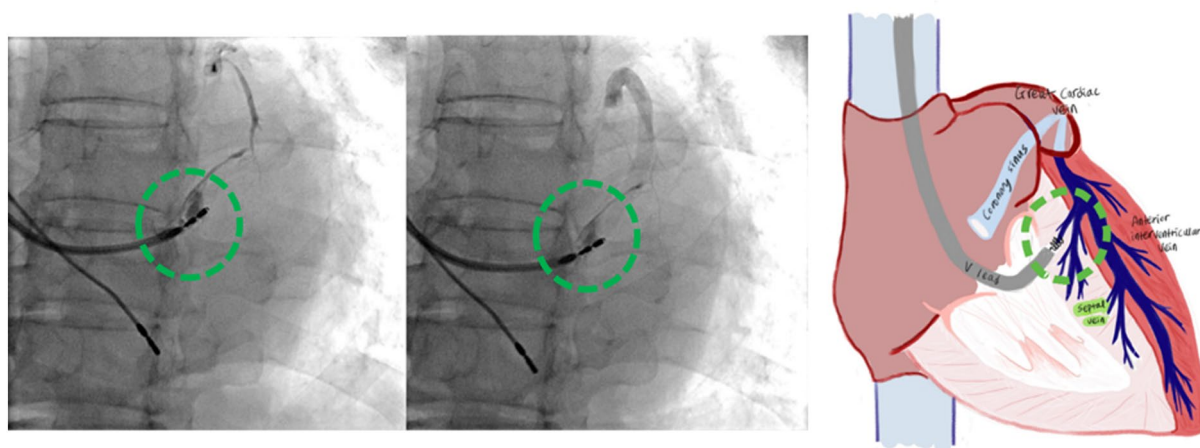
A 90-year-old man diagnosed with CAVB underwent the LBBAP procedure. DDD type of pacemaker with LBBAP (Biotronik, Solia S60) was used. According to the LBBAP protocol, the LBBAP sheath was placed at the RV (right ventricle) septal area, and the screw was inserted into the area, and then a contrast injection was performed to confirm whether the lead was positioned appropriately to the septum or not. However, the septal vein was identified with contrast injection unexpectedly and then coronary sinus drainage was noted (Fig. 3). The repositioning of the lead was decided due to concerns about complications, such as hematoma formation.

Fig. 3 Damage of the septal vein. The septal vein was damaged by V lead for LBBAP inserted into the septum (green dotted circle). By infusion of contrast, coronary sinus was identified along the septal vein

conduction system [5]. Considering cardiac vein anatomy, blood vessels are distributed in the septum. Because V lead should be inserted into the septum, damage to the vessel adjacent to the lead could occur. Therefore, detailed research on the blood vessel distribution around the conduction system is necessary. In case 2, we repositioned the V lead to another site and no further complication was identified. It is questionable whether minor damage to the septal vein by the lead causes additional complications at long-term follow-up or not.

These two cases are uncommon complications with the LBBAP procedure and the previous study to investigate the cause and solutions of the complications are lacking. We tried to focus on not only successful insertion appropriate for the protocol of LBBAP procedure is important, but also a deliberate approach for the procedure through various complications and long-term follow-up of complications should be needed. The case of failure in V lead extraction which is inserted into the ventricular septum emphasizes the demand for further traction maneuvers rather than conventional methods. Also, a careful approach is required as the process of inserting the V lead into the septum may cause damage to the vein.
